Exceptional service in the national interest

Annular Core Research Reactor Updates

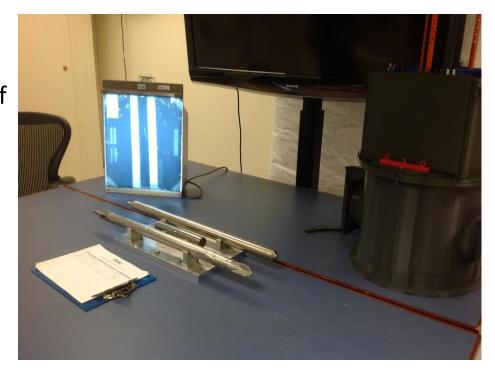
Neutron Radiography Tube

- The Neutron Radiography Facility provides a thermal neutron beam in a large cavity used for neutron imaging, has not been used since the addition of 6 new reactor operators.
- The ACRR neutron radiography system has four apertures (65:1, 125:1, 250:1, and 500:1) available to experimenters.
- The neutron flux rate and spectrum as well as the gamma dose rate were characterized at the imaging plane for the ACRR's neutron radiography system for the apertures

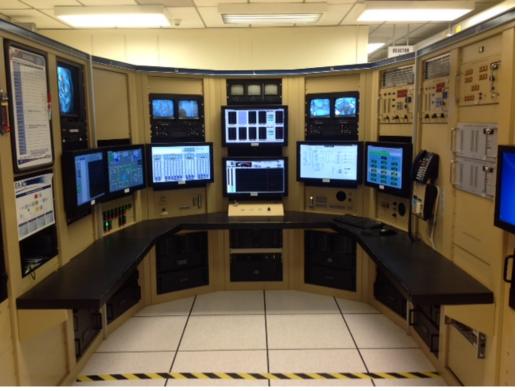
Before and After

- Replacement with new hardware, solid state drive upgrades, monitors.
 - Hardware was difficult to find that supported rod control system integrated hardware and current processors, ram, power supplies, etc.
 - Assembly of computers required some modifications to the cases to allow the programmable multi axis controllers used for rod movement to fit and connect to a PCI slot.
- Upgrading software not plug and play ⊗
 - Upgraded Windows XP to Windows 7 (Corporate requirement),
 LabView2002 to 2012, PMAC software, Microsoft Office.
 - Required new programming for LabView code to work with PMAC software and timing cards. Software changes needed to be transparent to operator for procedure compliance and best ConOps practices.

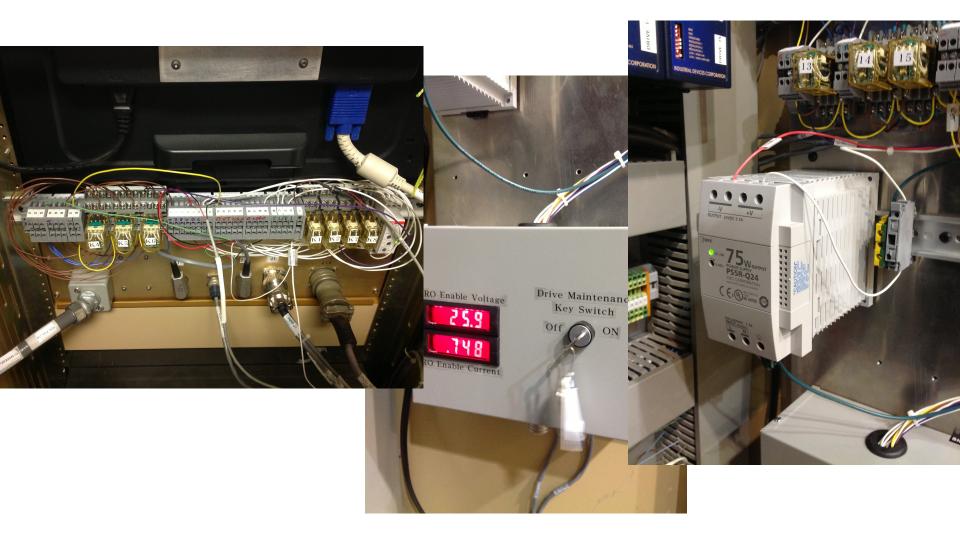
Enable Relay

- Controls rod drive power through LabView Fieldpoint and RO enable circuit.
- The operator must be issuing a command and the drive feedback must be responding to the command
- If not, an error occurs and drive motion is stopped by opening the relays controlling drive motion
- Once the error is reset normal drive motion can occur assuming there are no faults
- Monitors current and voltage to drives for troubleshooting

- Several occurrences of individual rods moving without commands
- One occurrence of control rod bank drives moving outward when commanded in
- Thought to be due to buffer overflows in the computing system for the rod controller
- Major code revision to prevent any more uncommanded rod motion
- Installed temporary modification to prevent rod motion if an error in motion logic is seen. Planning to remove after verification of new program is documented.
