Control Systems Upgrades at the Maryland University Training Reactor

University of Maryland Radiation Facilities

Maryland University Training Reactor

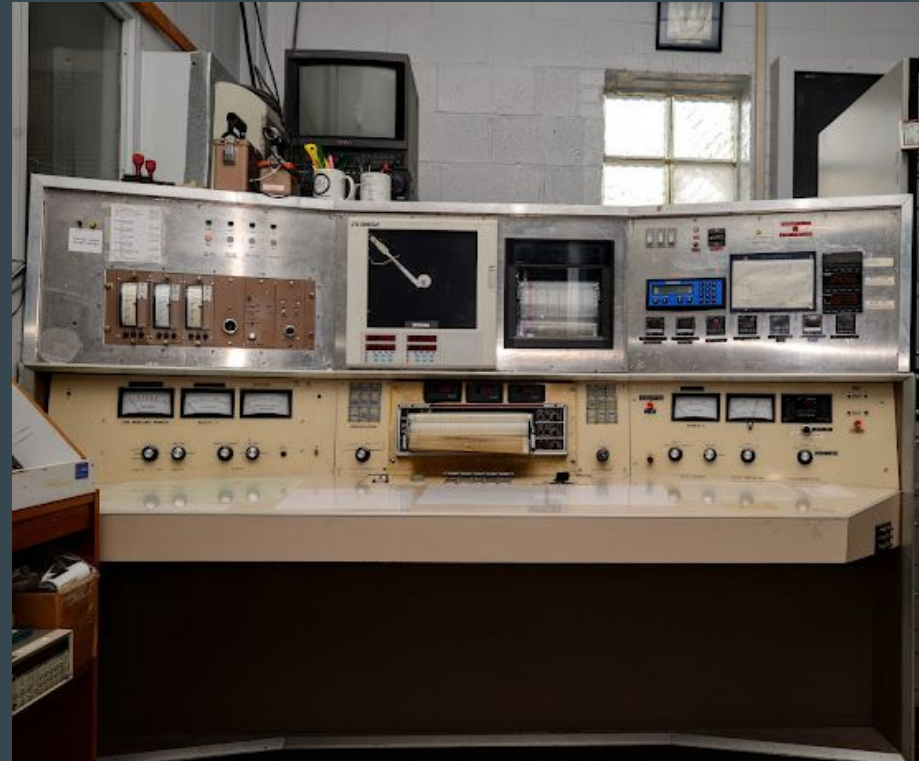
MUTR I&C - 2019

- Paper Chart Recorders
- Wide Range Channel unreliable
- Significant noise on reactor power channels during startup
- Frequent false period trips due to actuating console switches
- Unused instrumentation in console
- Large amounts of wiring abandoned in place

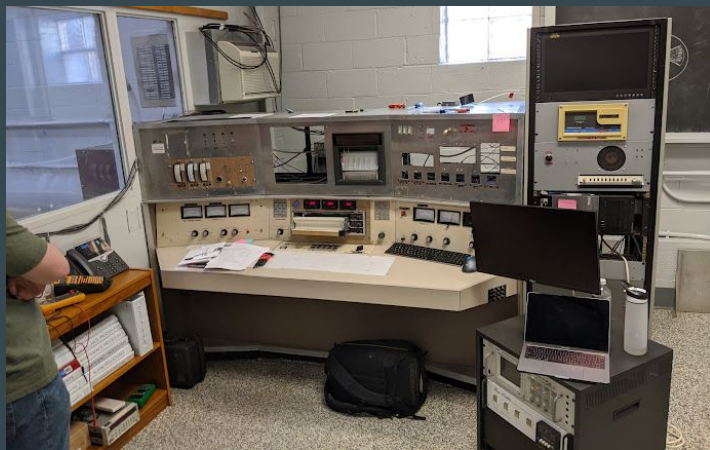
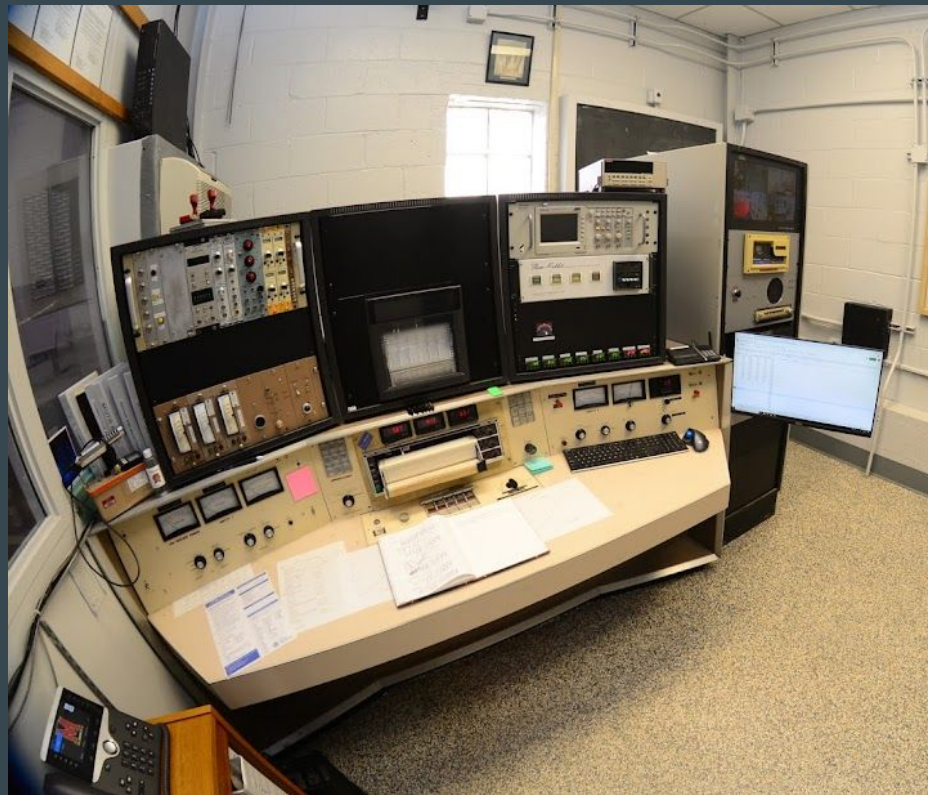
“Modular” Upper Console

- Replaced homemade Upper Console with 19” Racks
- Racks allow for easy replacement of panels and equipment for upgrades

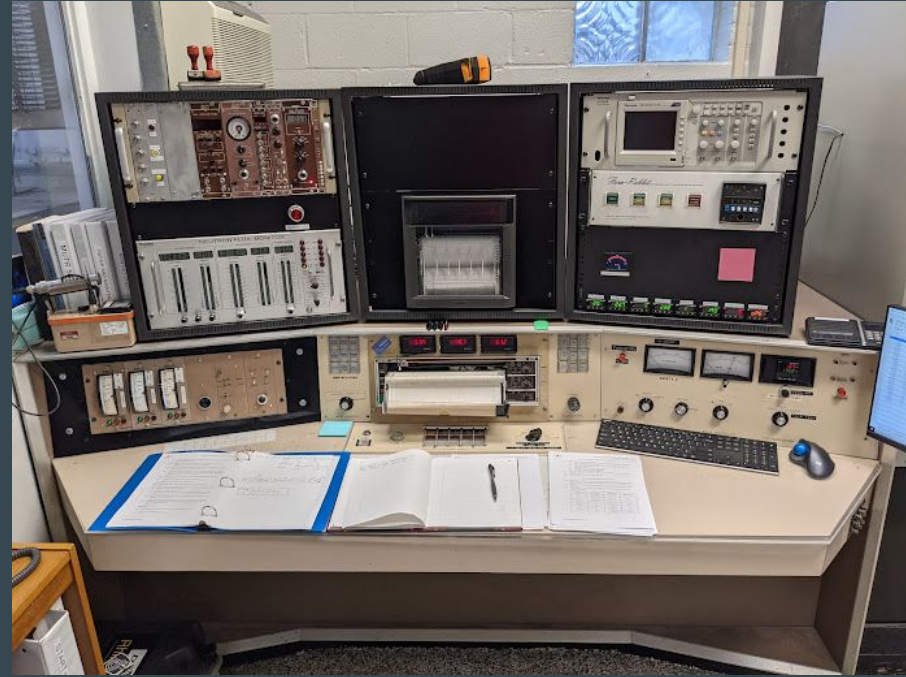
Fission Chamber and Wide Range Neutron Flux Monitor

- New fission chamber and Thermo Fisher TR-10 Neutron Flux Monitor
- Channel provides power and period scrams, count rate interlocks
- Replaced original, 49 year old fission chamber and channel
- Performance was greatly improved

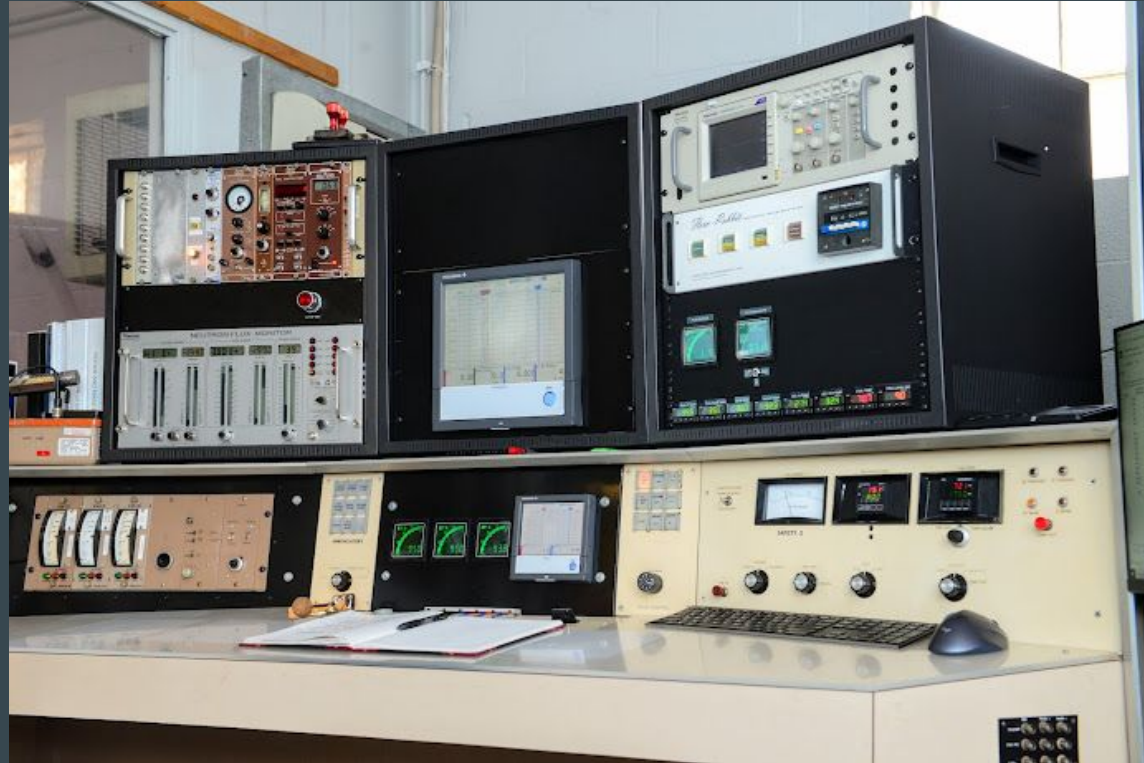
Digital Chart Recorders

- Yokogawa GX series digital chart recorders
- Nearly all channels recorded now
- Significantly easier to read and review data
- Considering networking recorders for remote access to reactor parameters

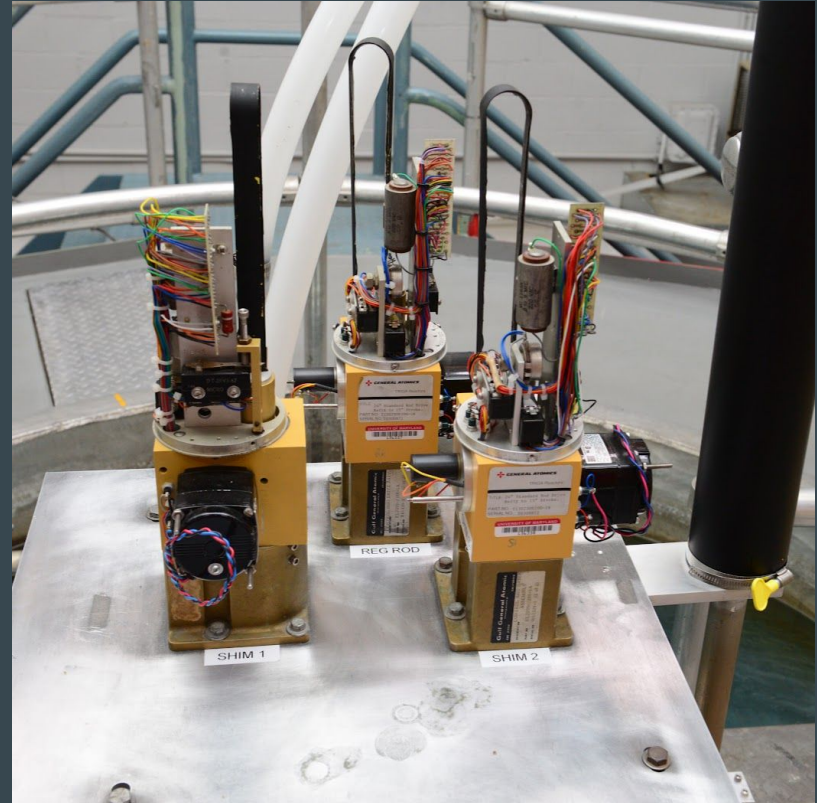
- Control Rod Position Indicators were experiencing significant drift from year to year
- Uncertainty in Rod Worth Curves
- System was returned to its original configuration
- High quality Acopian linear power supply was installed
- New Rod Position displays were installed which can retransmit a 4-20 mA signal for recording

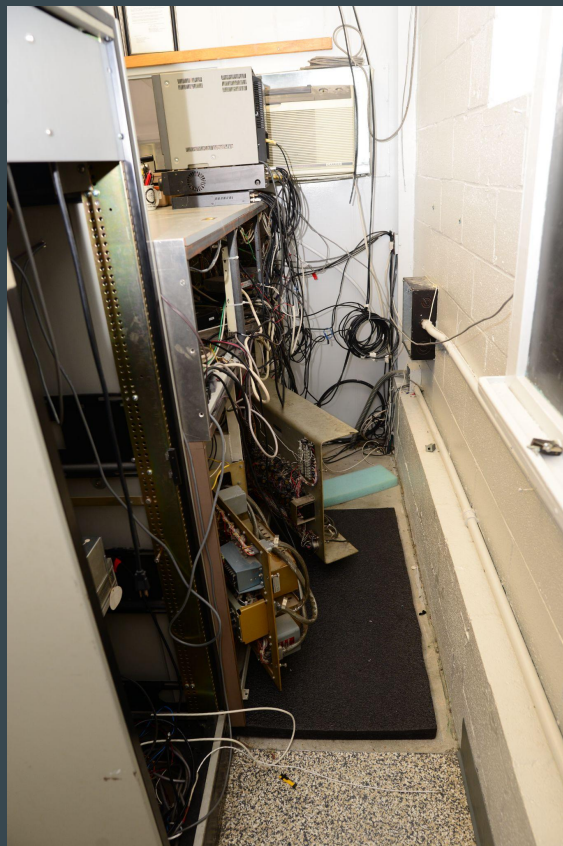
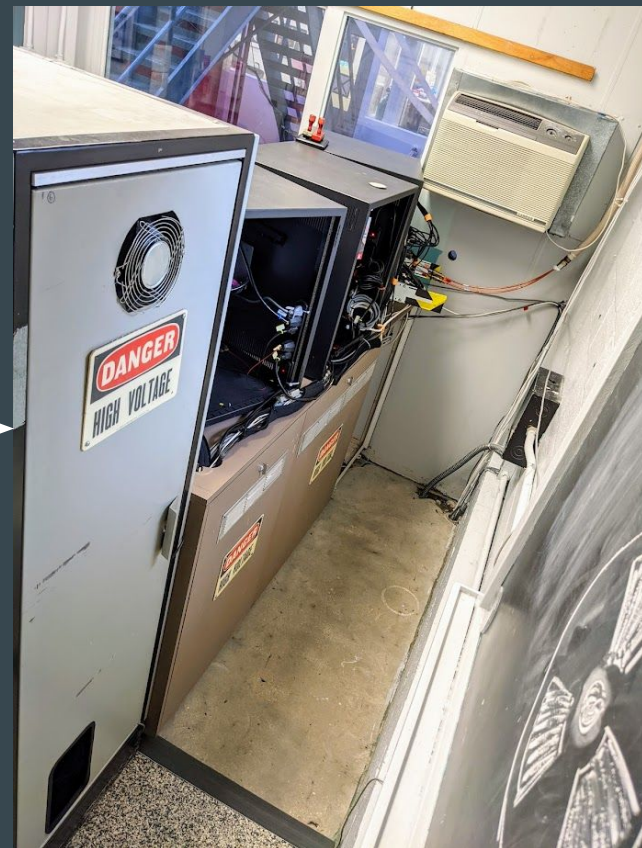
Console Cleanup

- Removed abandoned wires
- Shortened or rerouted wires
- Added labels
- Replaced doors on console

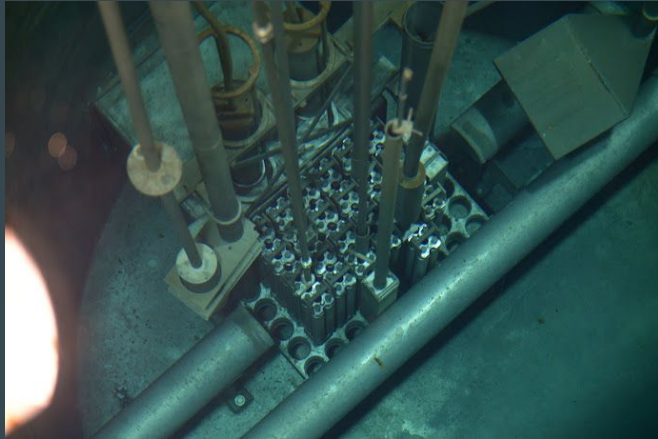
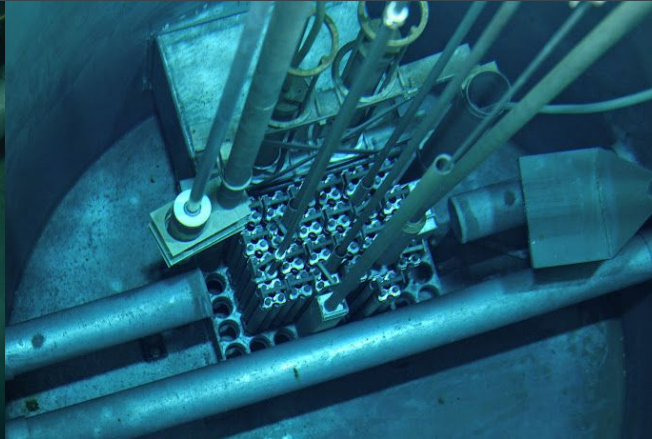
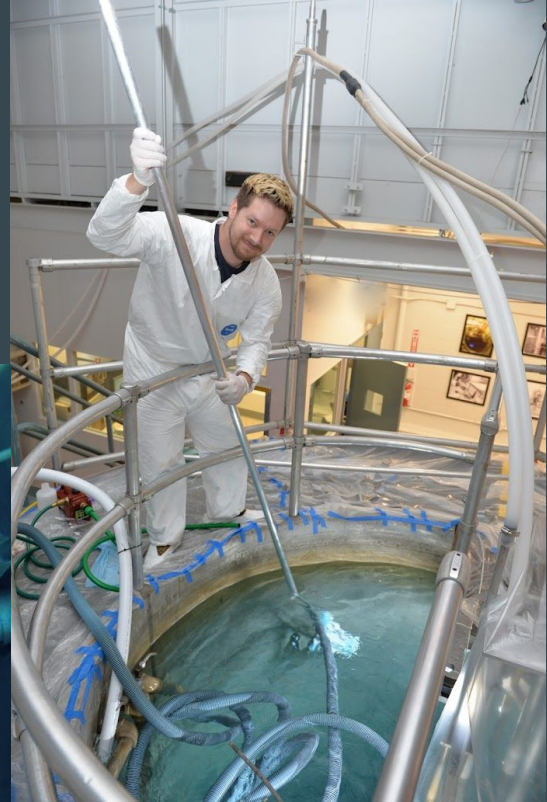
Reactor Pool Vacuuming

- Reactor Pool was vacuumed for the first time in approximately 30 years
- Off the shelf pool vacuum
- Procedure was performed with minimal contamination

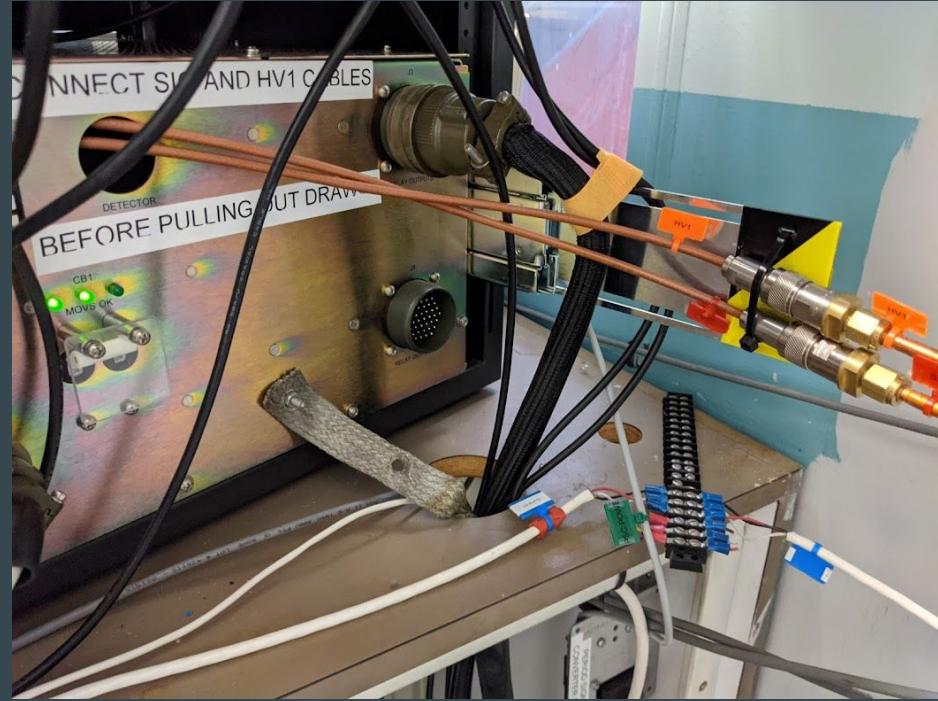
TR-10 Installation Issues

- Lack of HV Scram Test
 - Installed switch to cut off HV
- Insufficient contacts for interlocks
 - Significant delay for troubleshooting
- Detector positioning
 - Original mount did not allow detector close enough to core
- Cable fatigue
 - Stress on cable causes noise
